**IMPORTANT PRODUCT SAFETY NOTICE FOR GREENLEE® ESG45X/ESG45LX**

This Notice Applies To Greenlee ESG45LX / ESG45X Tools Produced from October 2016 to April 2023

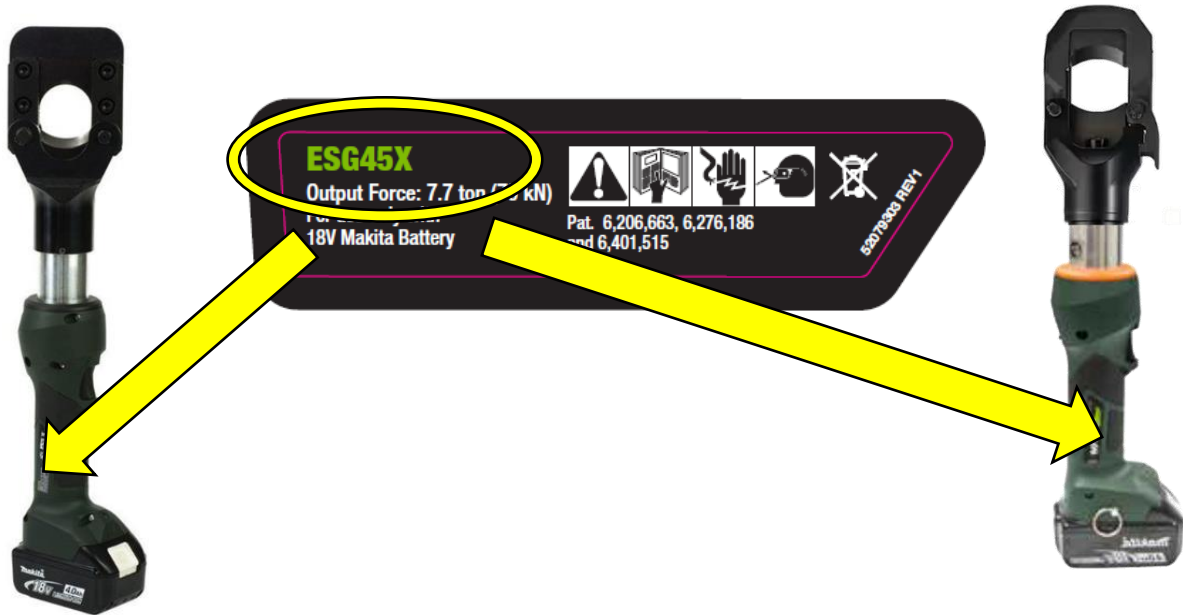
Figure 1 - Tool Model Identification and Decal Location

**STEP 1** – Inspect the tool decal to determine tool’s model (see, Figure 1 on page 1). If the tool model shows “ESG45X” or “ESG45LX”, continue to Step 2. No other Greenlee models are affected by this Notice.

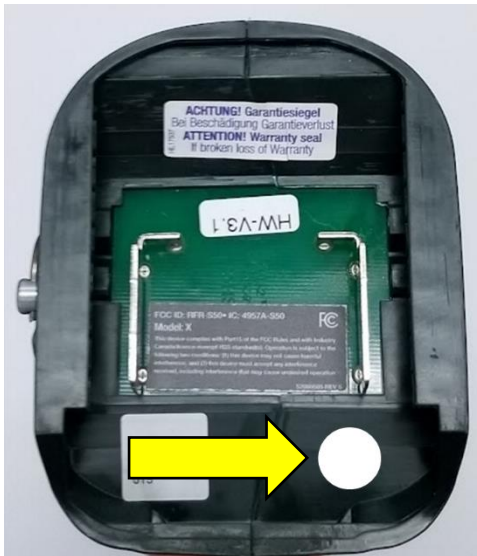
**STEP 2** – Remove battery from tool. Look into the battery shoe area, to determine if there is a White Dot as shown in Figure 2. If there is a White Dot, this tool has already been reworked and is not part of this notice. If there is no White Dot, continue to Step 3.

**Figure 2** – Inspect Battery Shoe area to determine if White Dot Present (Arrow shows White Dot indicating Tool not affected)

If your tool has a matching Date Code (Step 3) and NO White Dot is present (Figure 2) **your Tool is affected and must be returned to Greenlee. Do not continue to use the affected Tool.** You must immediately contact Greenlee Technical Service, either via email at [ProToolsTechService@Emerson.com](mailto:ProToolsTechService@Emerson.com) or

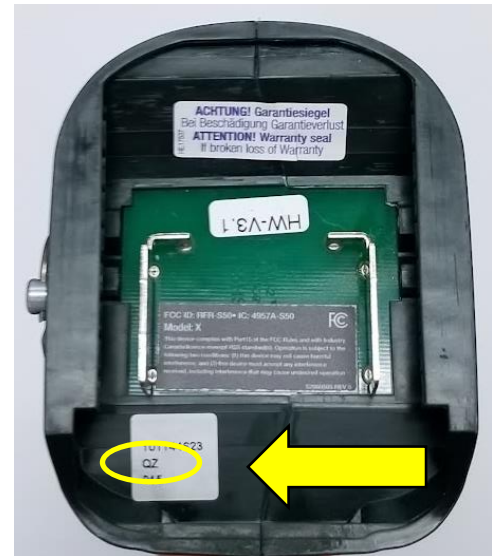
**Figure 3** – Determine two-character Tool Date Code (Circle shows “QZ” in this example)

**STEP 3** – If there is no White Dot, determine the two-character tool Date Code by looking at the serial number label (See Figure 3). If serial number label is missing, contact Greenlee for assistance. If the two-character Date Code listed on the tool serial number label is: KT, KV, KW, KX, KY, KZ, K1, LN, LP, LQ, LR, LS, LT, LV, LW, LX, LY, LZ, L1, MN, MP, MQ, MR, MS, MT, MV, MW, MX, MY, MZ, M1, NN, NP, NQ, NR, NS, NT, NV, NW, NX, NY, NZ, N1, PN, PP, PQ, PR, PS, PT, PV, PW, PX, PY, PZ, P1, QN, QP, QQ, QR, QS, QT, QV, QW, QX, QY, QZ, Q1, RN, RP, RQ, RR, RS, RT, RV, RW, RX, RY, RZ, R1, SN, SP, SQ, SR, or SS, and no White Dot is present your ESG45X/ESG45LX is affected and must be returned to Greenlee. Do not continue to use the Tool. Contact Greenlee using the information provided below.
