IMPORTANT SAFETY NOTICE FOR GREENLEE® ORANGE TOOLS

Greenlee Orange Tools models EK425VX & ECS50HVX produced between December 2021 and January 2023

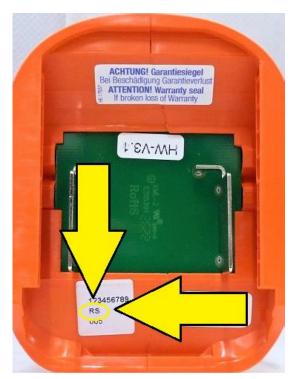
Figure 1 – Date Code Location

STEP 1 – Remove the battery from the Orange Tool unit in question and identify the two character Date Code listed on the second row on the serial number label, as pictured below (see, Figure 1).

STEP 3 – If the two character Date Code listed on the second row of the serial number label appearing are: **Q1, RN, RP, RQ, RR, RS, RT, RV, RW, RX, RY, RZ, R1** or **SN,** and no Green Dot is present your Orange Tool is affected and must be returned to Greenlee. Do not continue to use the Orange Tool. Contact Greenlee using the information provided below.

If your unit does not contain a Green Dot <u>and</u> the date code appearing second row of the serial number label is: **Q1**, **RN**, **RP**, **RQ**, **RR**, **RS**, **RT**, **RV**, **RW**, **RX**, **RY**, **RZ**, **R1** or **SN** <u>your Orange Tool is affected and must be</u> returned to Greenlee. Do not continue to use the affected Orange Tool. You must immediately contact Greenlee Technical Service, either via email at <u>ProToolsTechService@emerson.com</u> or by phone at 844-789-8665 to arrange for a free shipping code to send the Orange Tool back to Greenlee for inspection and service work. Greenlee will return the Orange Tool to you at no charge once the inspection and service is completed.

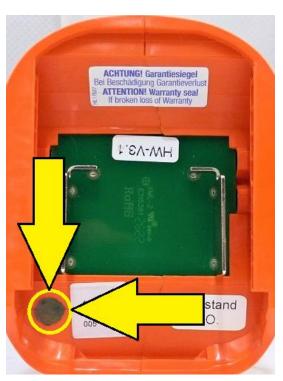
Figure 2 – Green Dot Location

STEP 2 – look for the presence of a Green Dot in the corner next to the serial number label (figure 2)

This announcement is not applicable if your unit contains a Green Dot in the corner next to the serial number label <u>and</u> your Orange Tool falls into the possibly affected product range. In this case, your unit has already been reworked by Greenlee. If your unit's date code does not fall into the above date range, your unit is also not affected by this announcement.
